SILVER LAKE DAM

PHASE I INSPECTION REPORT NATIONAL DAM SAFETY PROGRAM

DE 00041

JUNE 1978

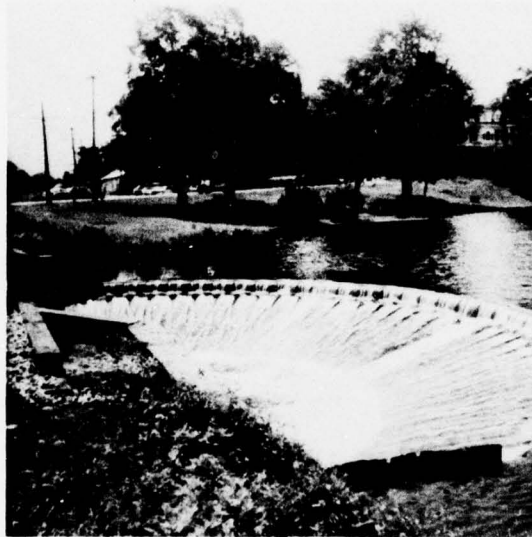
OVERALL VIEW OF DAM

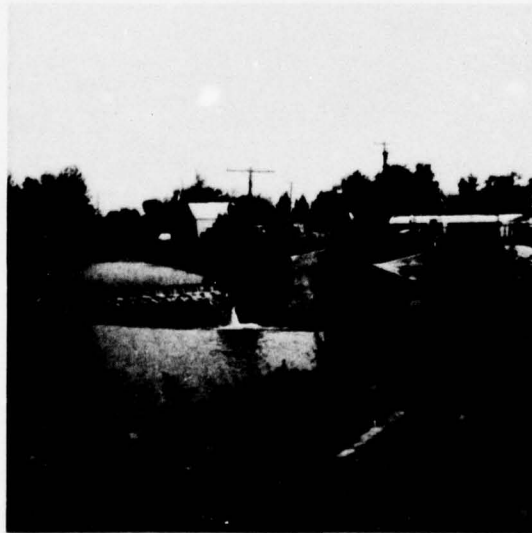
VIEW OF DAM AND RAILROAD BRIDGE

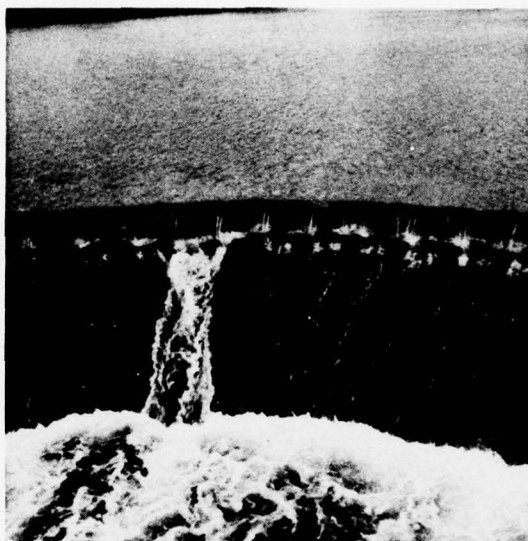
a. Visual Observation - No indications of structural stress were evident during the inspection of the sheet piling spillway. A depression in the apron downstream of the center of the sheeting was noted, but it could not be determined whether this was by design or due to foundation settlement.

DEPRESSION AT CENTER OF DAM

A depression in the concrete apron was observed. No depression was shown on the plans.

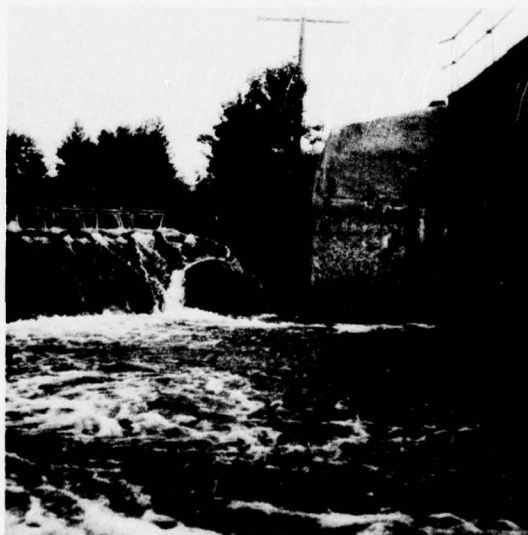
The 48-inch diameter pipe located on the left side of the spillway was not discharging at the time of inspection. The baffle boards which control flow through this pipe could not be observed due to the water level.

DISCHARGE PIPE AT LEFT ABUTMENT OF DAM

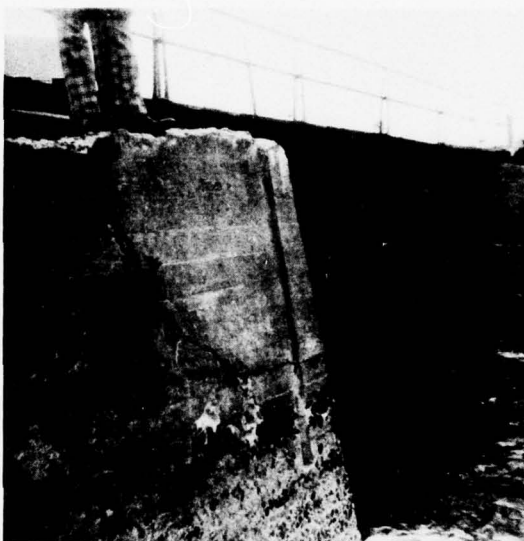
The wing walls of the railroad bridge show significant deterioration and structural stress. Concrete aggregate is exposed on the top surface of the wing walls and major horizontal and vertical cracks extend throughout the wing walls and endwalls of the concrete abutments. Aggregate is exposed in the walls in the lower half of the vertical height.

The concrete walls of the railroad bridge abutments which anchor the spillway sheet piling appear to be in poor structural condition.

CRACK IN RAILROAD BRIDGE WINGWALL (LEFT ABUTMENT)

b. Monitoring of any changes in the structural condition of the railroad bridge abutments, which anchor the dam, should commence within three months of the date of approval of this report.

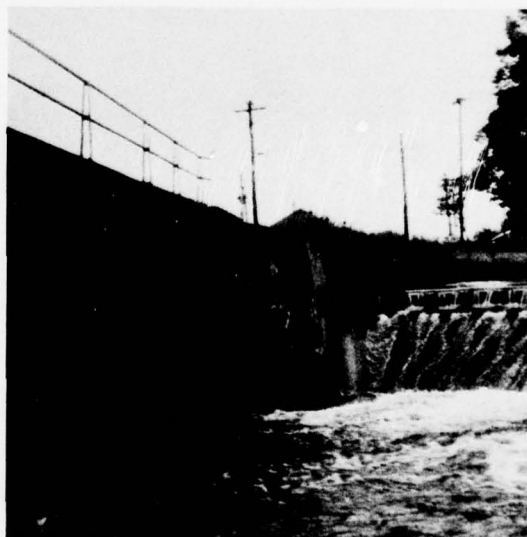
VIEW OF CRACK AND EXPOSED AGGREGATE IN RAILROAD
BRIDGE ENDWALL (RIGHT ABUTMENT)

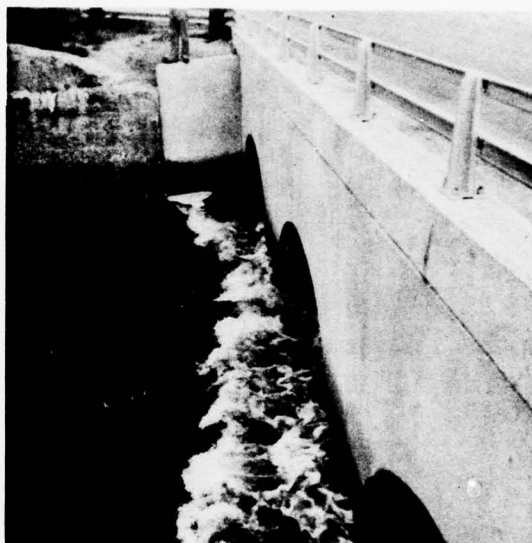
A new concrete highway bridge, which appears to be in excellent condition, is located immediately downstream of the railroad bridge. Three corrugated metal pipe arches, each with a span of about fifteen feet, form the waterway under this bridge.

FLOW AT DOWNSTREAM HIGHWAY BRIDGE

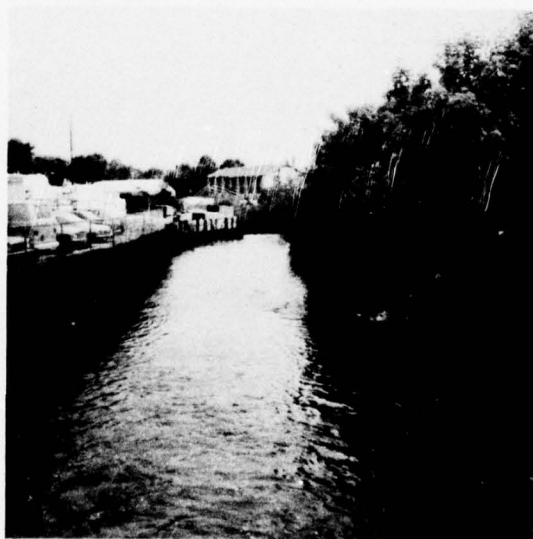
e. Downstream Channel - The left bank of the outlet channel downstream of the highway bridge is lined with steel sheet piling for a distance of about three hundred feet. The right bank in the same area is protected with broken concrete slabs which serve as riprap slope protection. Commercial establishments are located on the property adjacent to both banks. Further downstream, the channel continues through the community of Milford.

VIEW OF DOWNSTREAM CHANNEL
